# Natural wetland condition factors

# Constructed wetland condition factors

# Grass filter strip definition

# Grass filter strip bypass

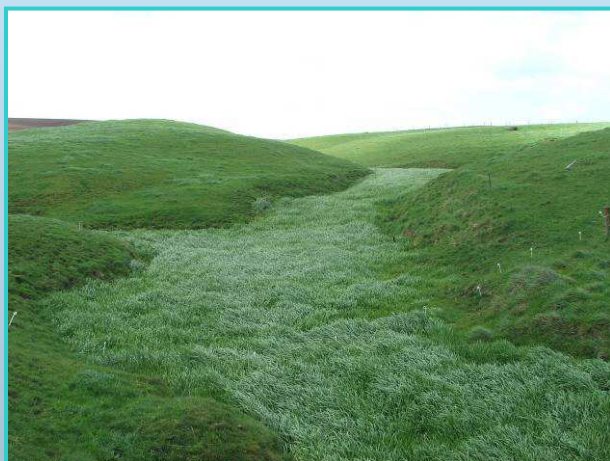
**Location:** Toenepi, Waikato

- surface flow evenly distributed
- unfenced
- grazed by cattle
- no evidence of pugging or channelisation

**Class: 1**

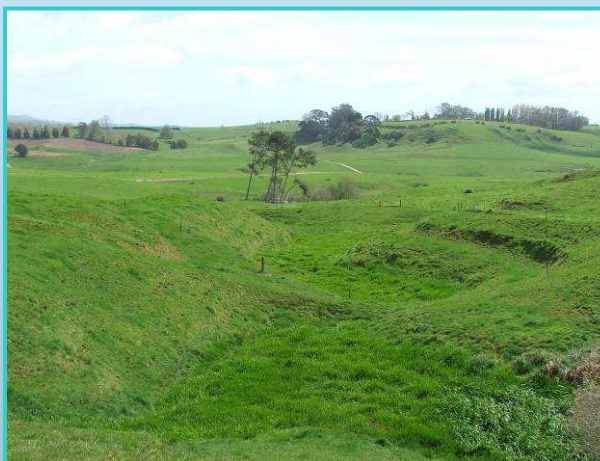
**Location:** Toenepi, Waikato

- surface flow evenly distributed
- unfenced
- grazed by cattle
- minor pugging & channelisation

**Class: 2**

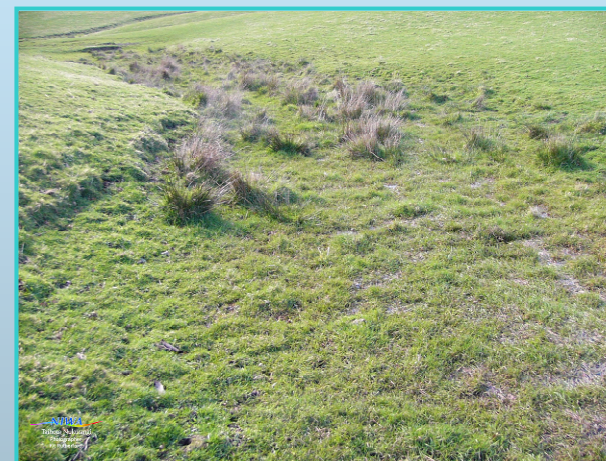
**Location:** Glenross Rd, Hastings

- surface flow evenly distributed
- unfenced
- grazed by sheep
- minor pugging

**Class: 2**

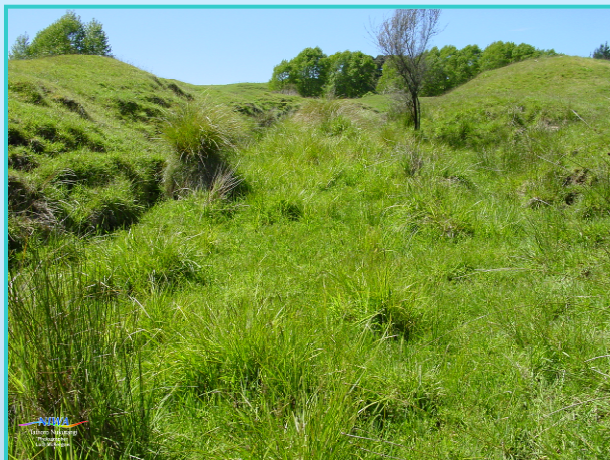
**Location:** Puketapu Rd, Lake Taupo

- surface flow evenly distributed
- unfenced and grazed by cattle
- minor pugging damage

**Class: 2**

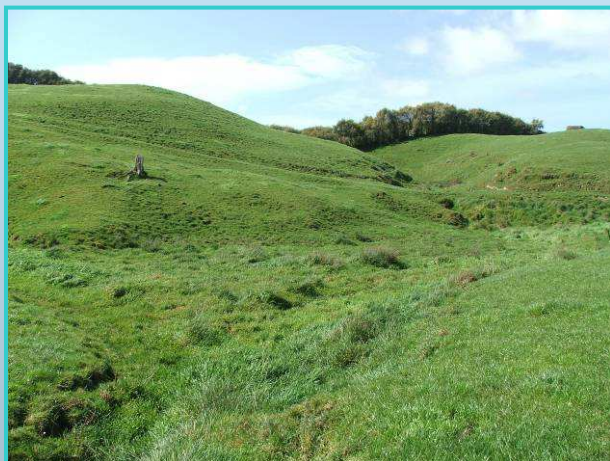
**Location:** Toenepi, Waikato

- no major channels through wetland
- unfenced and grazed
- dense vegetation
- fairly uniform flow distribution

**Class: 2**

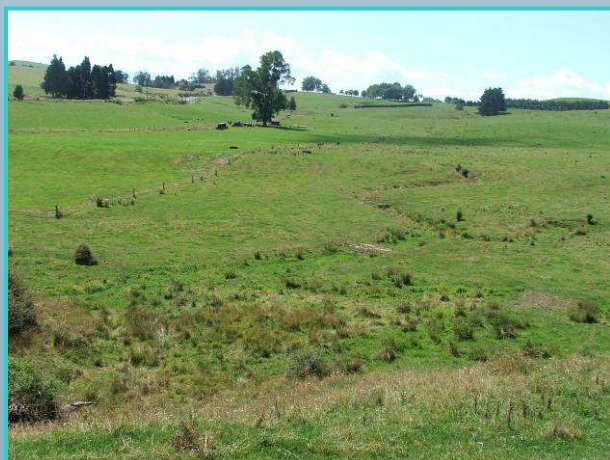
**Location:** Toenepi, Waikato

- no major channels
- unfenced and grazed
- light, patchy vegetation
- fairly uniform flow distribution

**Class: 3**

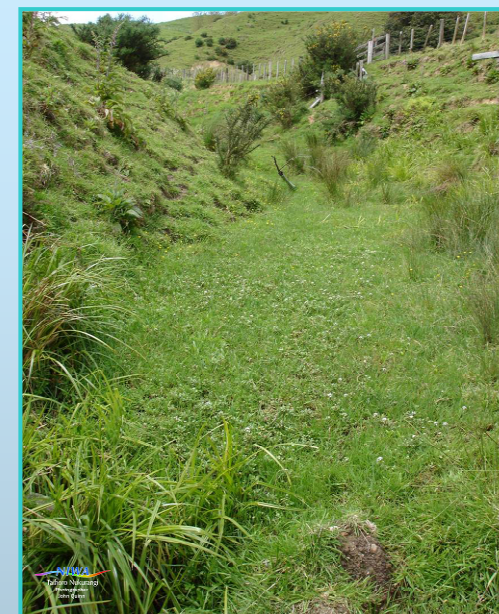
**Location:** Whatawhata, Waikato

- no channelisation
- unfenced and grazed by sheep
- dense grass cover
- fairly uniform flow distribution

**Class: 2**

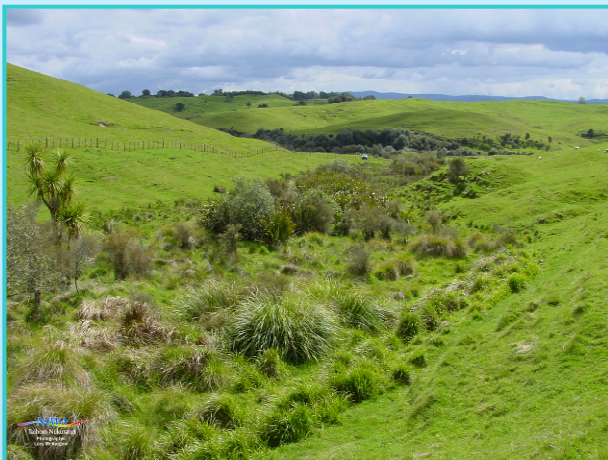
**Location:** Whangamata Rd, Lake Taupo

- moderate channelisation (hard to see entering the vegetation)
- unfenced, margins grazed with moderate pugging
- dense vegetation

**Class: 4**

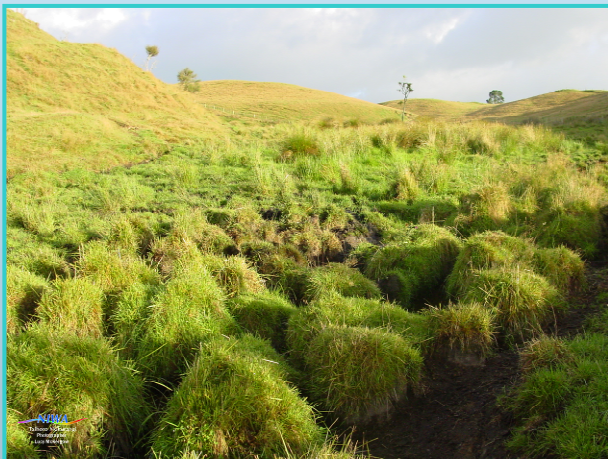
**Location:** Puketapu Rd, Lake Taupo

- highly channelised in foreground, less channelised upslope
- unfenced and grazed by cattle
- major pugging damage
- fairly uniform flow distribution

**Class: 4**

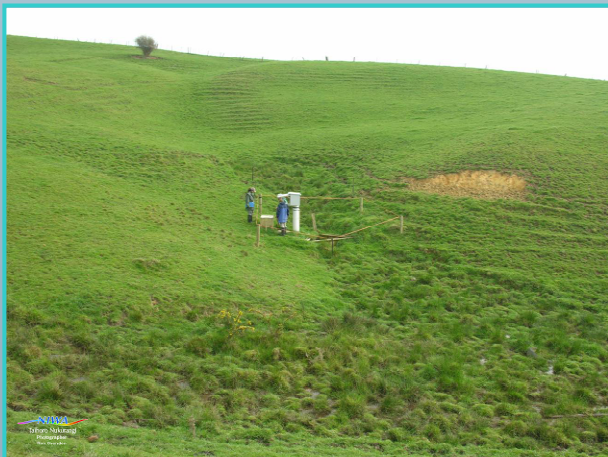
**Location:** Totara Park, Manukau City

- moderate channelisation
- unfenced
- grazed by cattle
- severe pugging damage

**Class: 4**

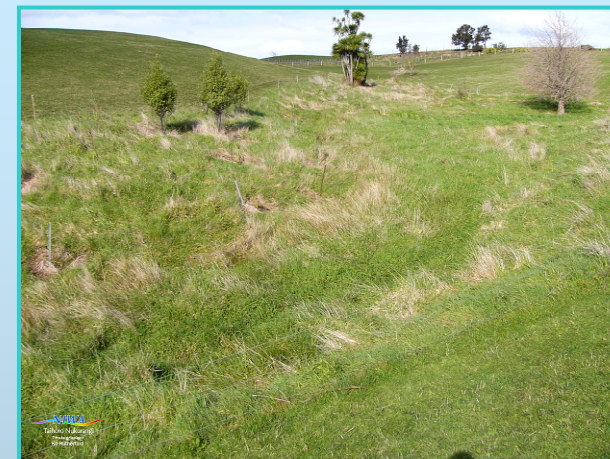
**Location:** Glenross Rd, Hastings

- moderate channelisation (hard to see without parting the grass)
- fenced and ungrazed
- dense vegetation
- fairly uniform flow distribution

**Class: 4**

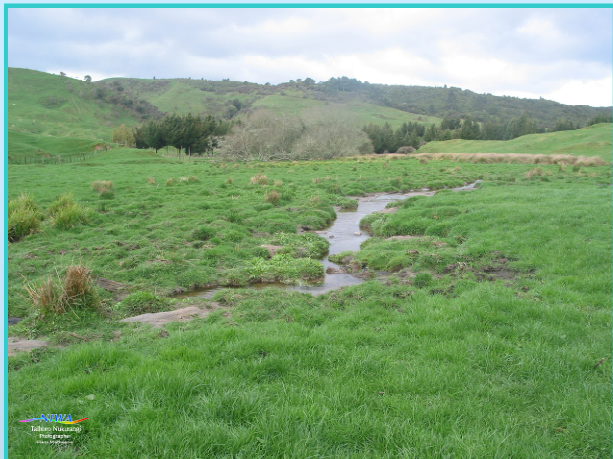
**Location:** Puketapu Rd, Lake Taupo

- incised channel
- unfenced,
- grazed by cattle and sheep
- major pugging & channelisation

**Class: 5**

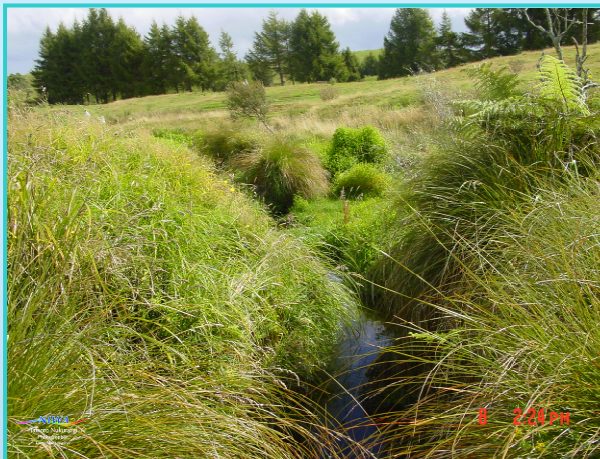
**Location:** Whangamata Rd, Lake Taupo

- highly channelised wetland with deeply incised channel
- unfenced, margins grazed with moderate pugging
- dense vegetation

**Class: 5**

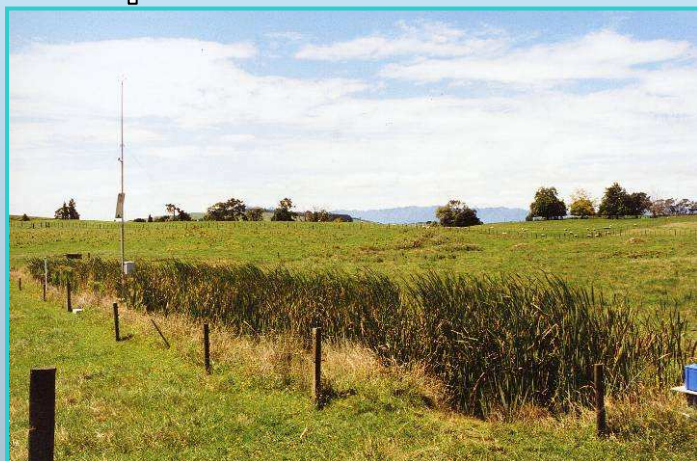
**Location:** Toenepi, Waikato

- linear
- two stage (two wetlands in series)

**Class: 1**

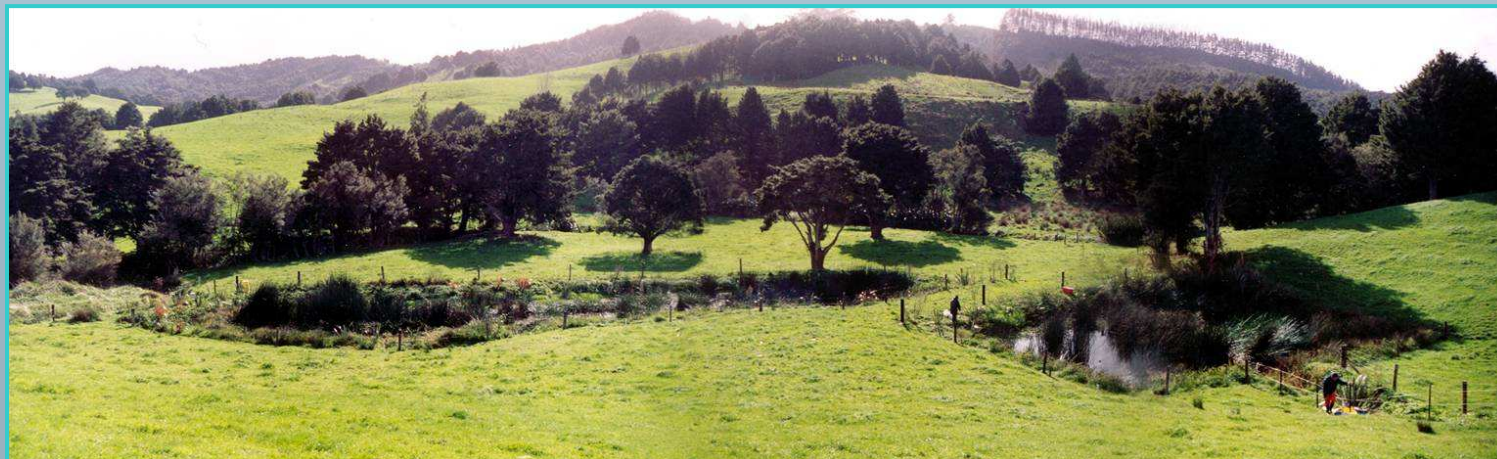
**Location:** Titoki, Northland

- linear
- two stage (pond \_ wetland in series)

**Class: 1**

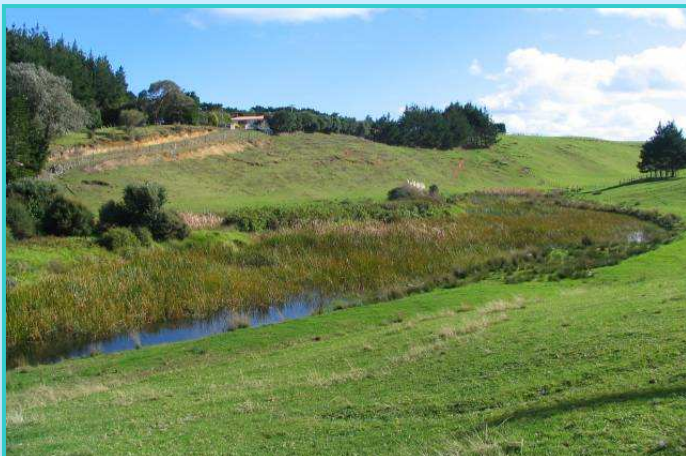
**Location:** Kai Iwi, Northland

- long, linear
- well vegetated

**Class: 1**

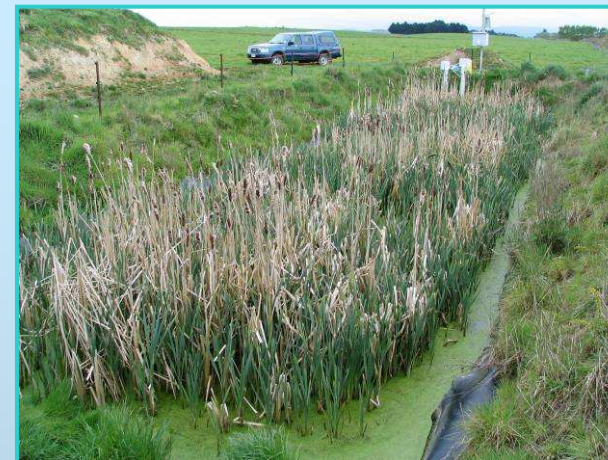
**Location:** Bog Burn, Southland

- single stage (one wetland)
- well vegetated

**Class: 2**

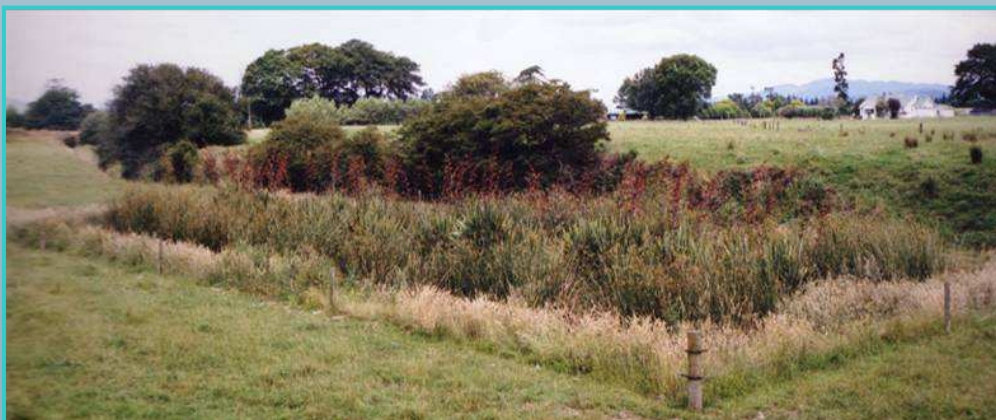
**Location:** Hautapu, Waikato

- single stage (one wetland)
- dense vegetation

**Class: 2**

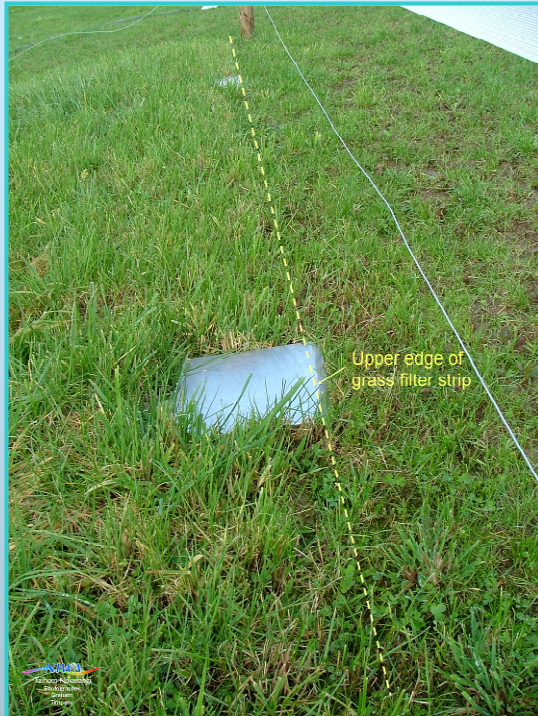
**Location:** Brett Rd, Rerewhakaaitu

- dense grass barrier with high density of stems 0-5 cm
- filter strip on contour
- no channels visible

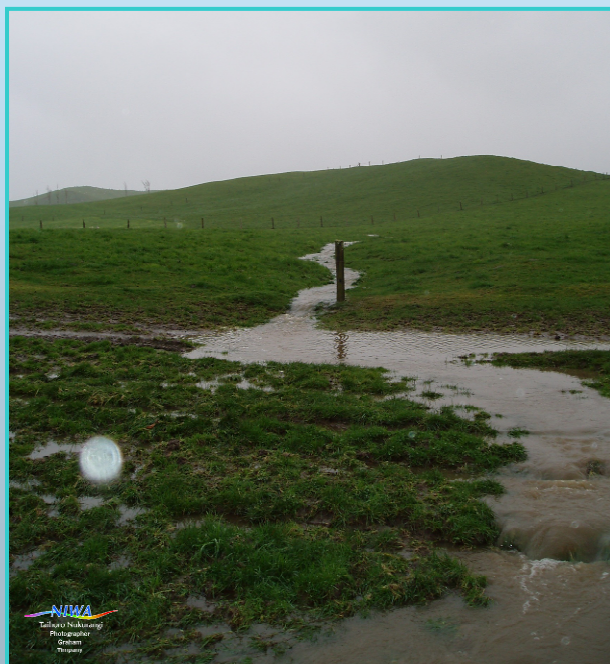
**Location:** Brett Rd, Rerewhakaaitu  
**Condition description:**  
 ▪ Highly channelised flow in paddock  
**Bypass fraction:** 0.75

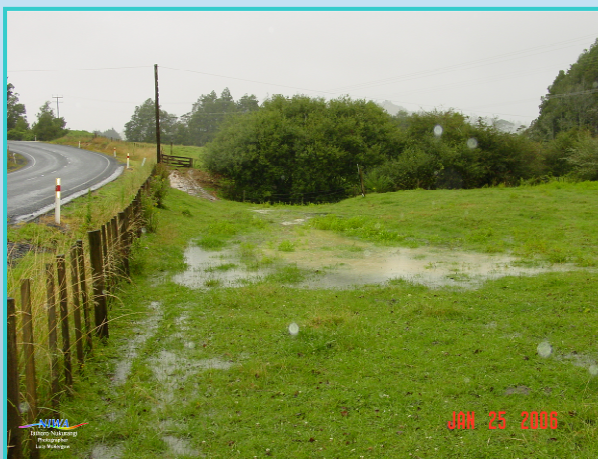
**Location:** SH23, Waitetuna  
**Condition description:**  
 ▪ half channelised flow in paddock  
**Bypass fraction:** 0.5

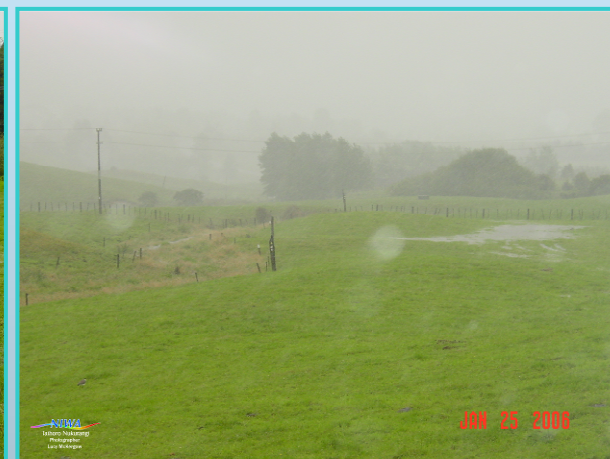
**Location:** SH23, Waitetuna  
**Condition description:**  
 ▪ a bit of channelised flow in paddock  
**Bypass fraction:** 0.25
